Contract Report:

CSIR/BE/TIE/IR/2013/0047/B

Long Term Pavement Performance monitoring of High Modulus Asphalt (HiMA) trial section on South Coast Road in eThekweni:

April 2013 survey

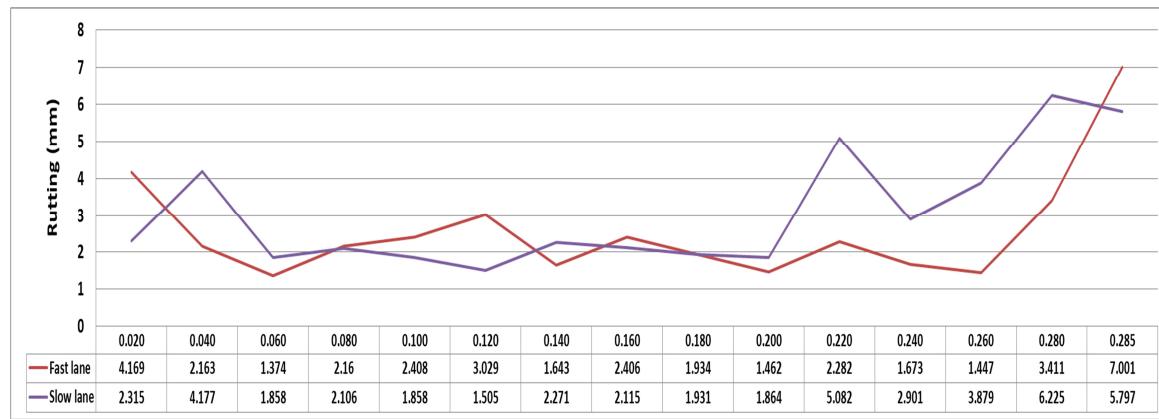
Figure 5: Rutting profile for slow and fast lanes

Several millimetres of rutting were recorded on the section for both lanes including the turning lane as shown in Figure 5, although this deformation seems to be limited to the SMA layer. Average rutting of 3.059 mm, 2.571mm and 5.497mm were measured in the slow, fast and turning lanes respectively. Analysis of the trend in permanent deformation has not been performed to detail, this will be performed after the last survey (August 2013), taking into account all the data from the time of construction.

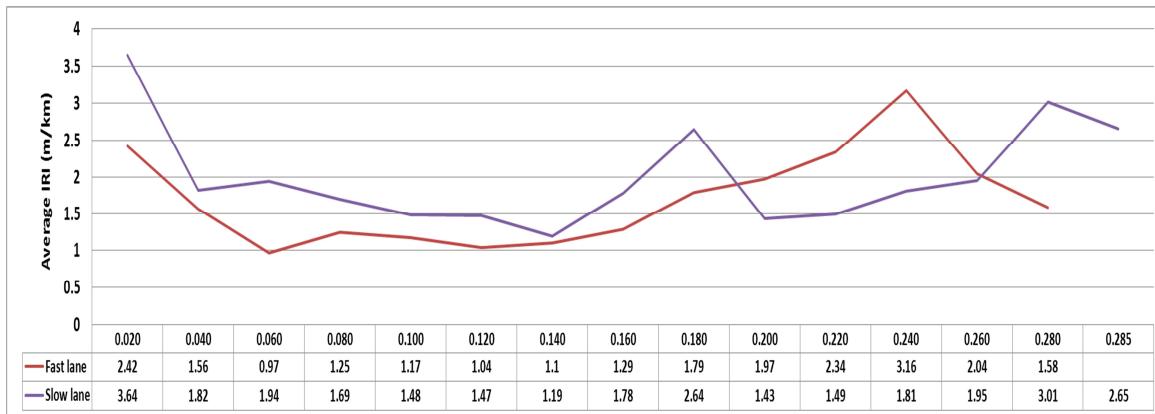
Figure 7: Roughness measurements for slow and fast lanes

A summary of the measured roughness in terms of the International Roughness Index (IRI) is also contained in Appendix C. The roughness measured along the section averaged 1.999 m/km and 1.980 m/km for the slow lane and fast lane respectively. Figure 7 shows the average IRI measured along the section for both lanes.

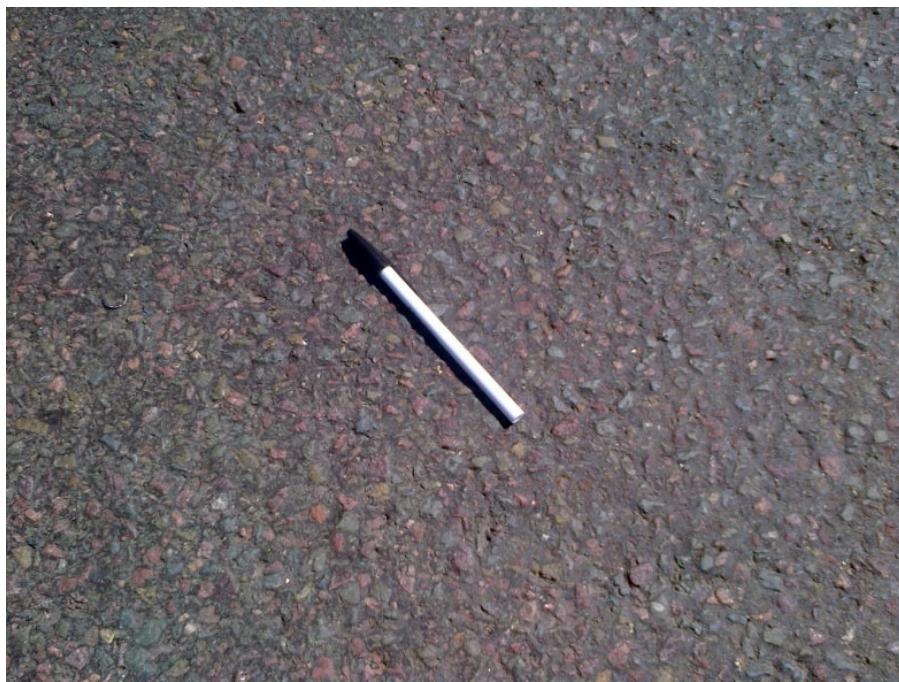
The most common distress type observed appears to be flushing (bleeding) on the SMA surfacing. The layer appears to have densified even further under heavy traffic after the second survey. In general the voids appear to vary from none to few in some segments of both lanes. There seems to be deterioration in surface texture and polishing of aggregates by traffic action (some appear smooth and rounded) on the SMA, and this condition has deteriorated since the previous survey. The surface texture was found variable from fine to medium for almost the entire section in both lanes, hence skid resistance could be an issue during rainy weather conditions. The conditions of both surface drainage and side drainage (which some are blocked, forming localised ponding) are of a concern too and need attention. Ineffective run-off drainage was observed during the inspection which could exacerbate the problems with skid resistance, and possibly weaken the pavement structure.

Figure 9: General texture on the surfacing (almost voidless)

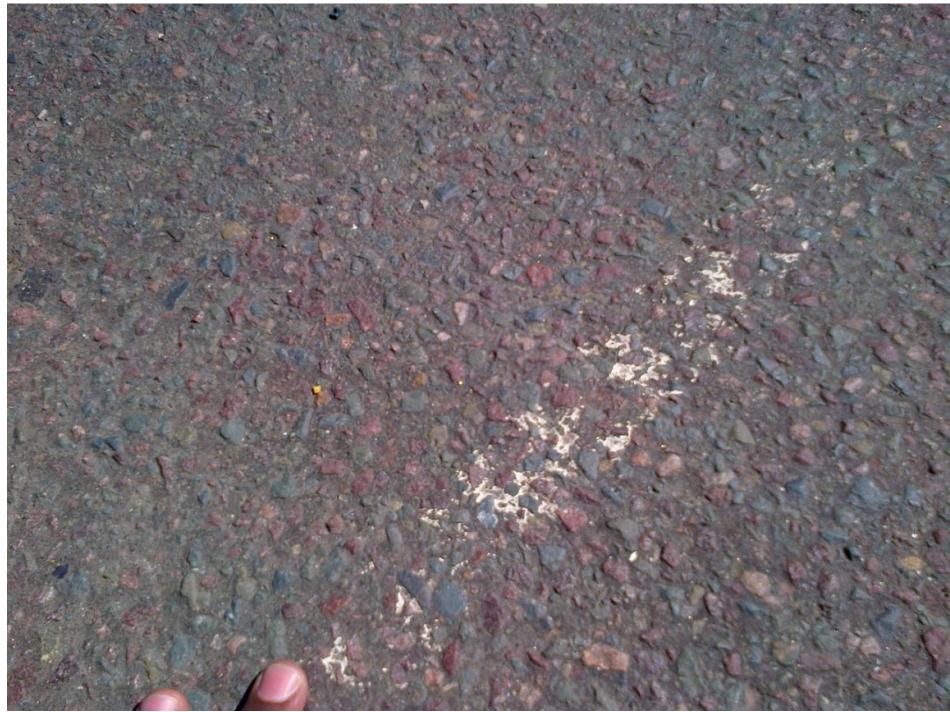
Figure 10: Aggregates appear smooth and rounded, polishing by traffic action

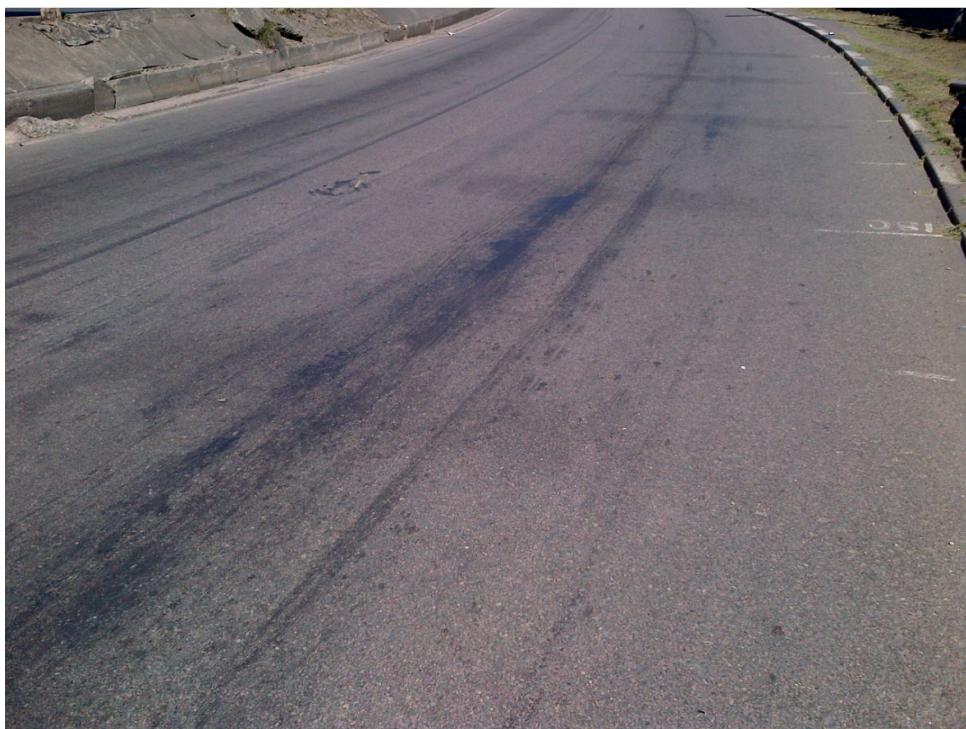
Figure 11: Flushing/bleeding in the wheel tracks

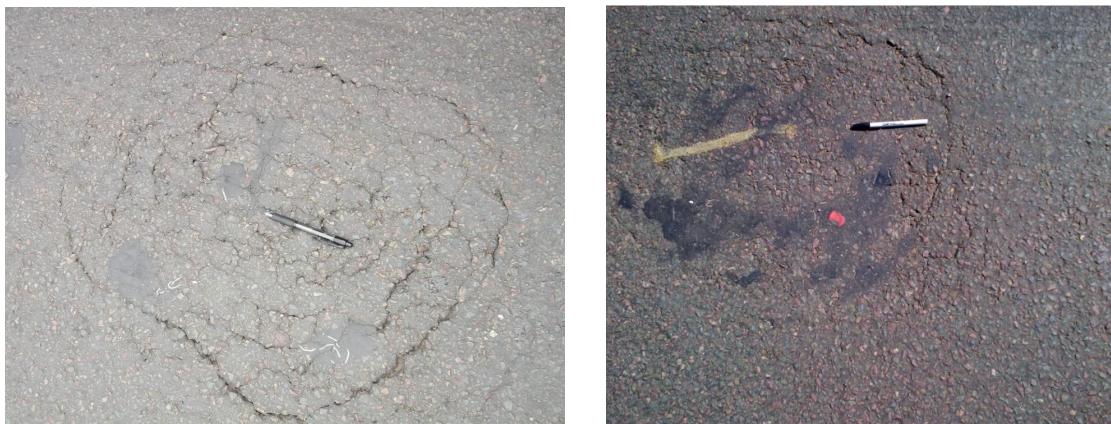
| Date | 05/04/2013 | | | | | | | | | | | | |
|--|---|---|---|---|---|---|---|---|---|---|---|---|---|
| Block crack has stabilized since the previous inspection | | | | | | | | | | | | | |

Figure 12: Block cracking observed with slight deformation, before and recently

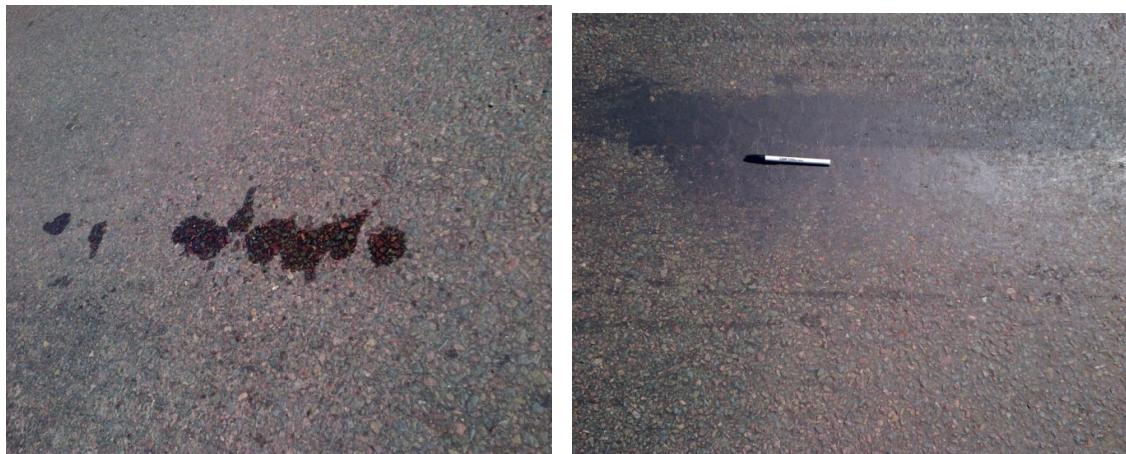
Figure 13: Isolated spillages occurring frequently, some resulting in flushing

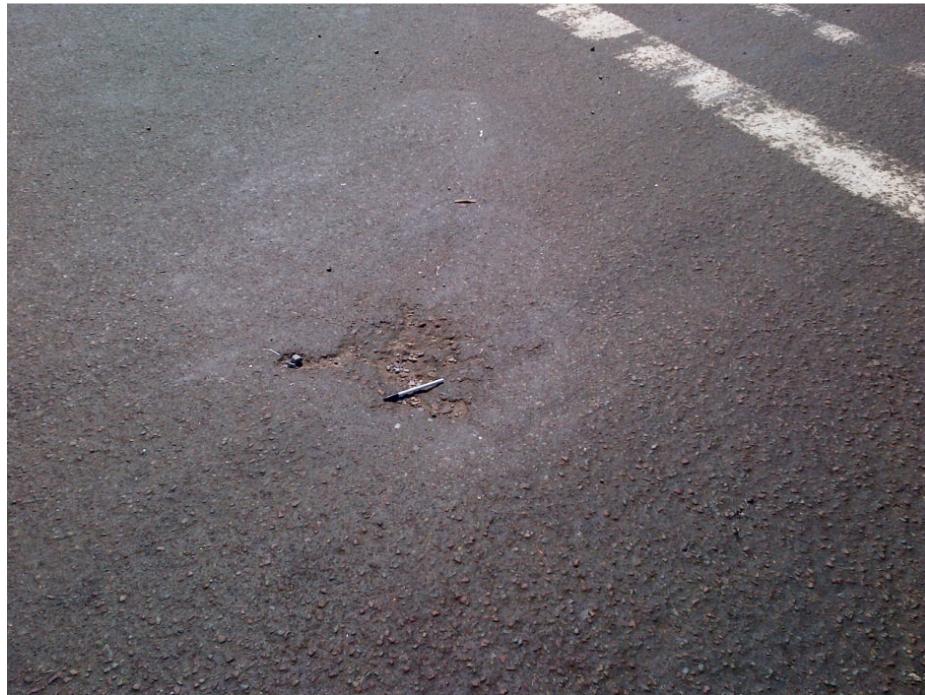
Figure 15: Deformation with aggregate loss observed on the fast lane (just at the intersection)

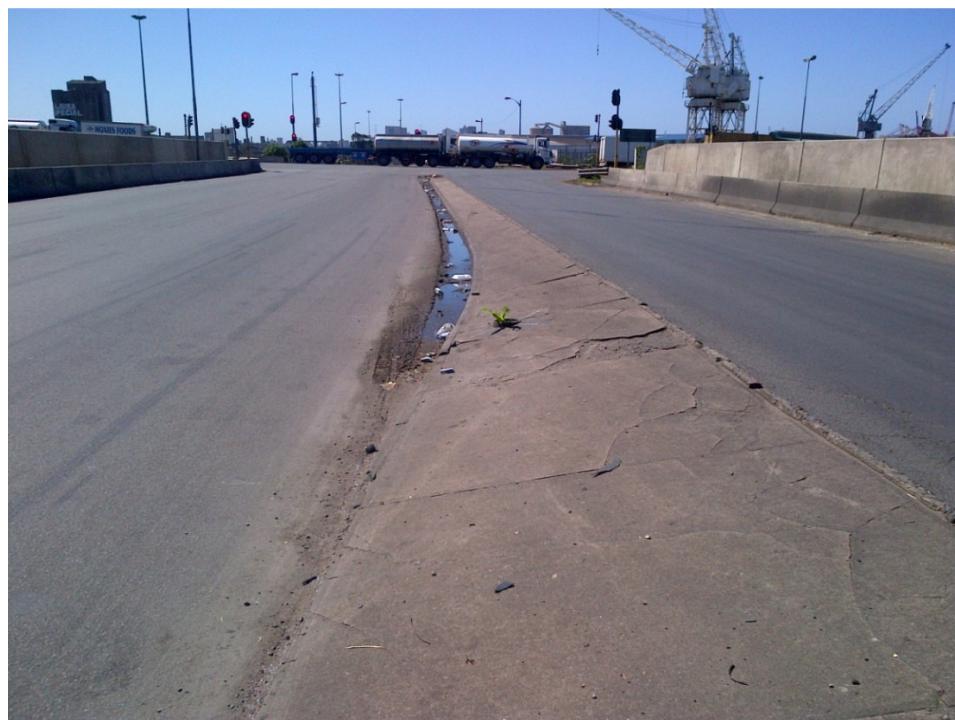
Figure 16: Drainage problems on the bridge deck at the intersection
