Contract Report:

CSIR/BE/TIE/IR/2013/0047/B

Long Term Pavement Performance monitoring of High Modulus Asphalt (HiMA) trial section on South Coast Road in eThekweni:

April 2013 survey

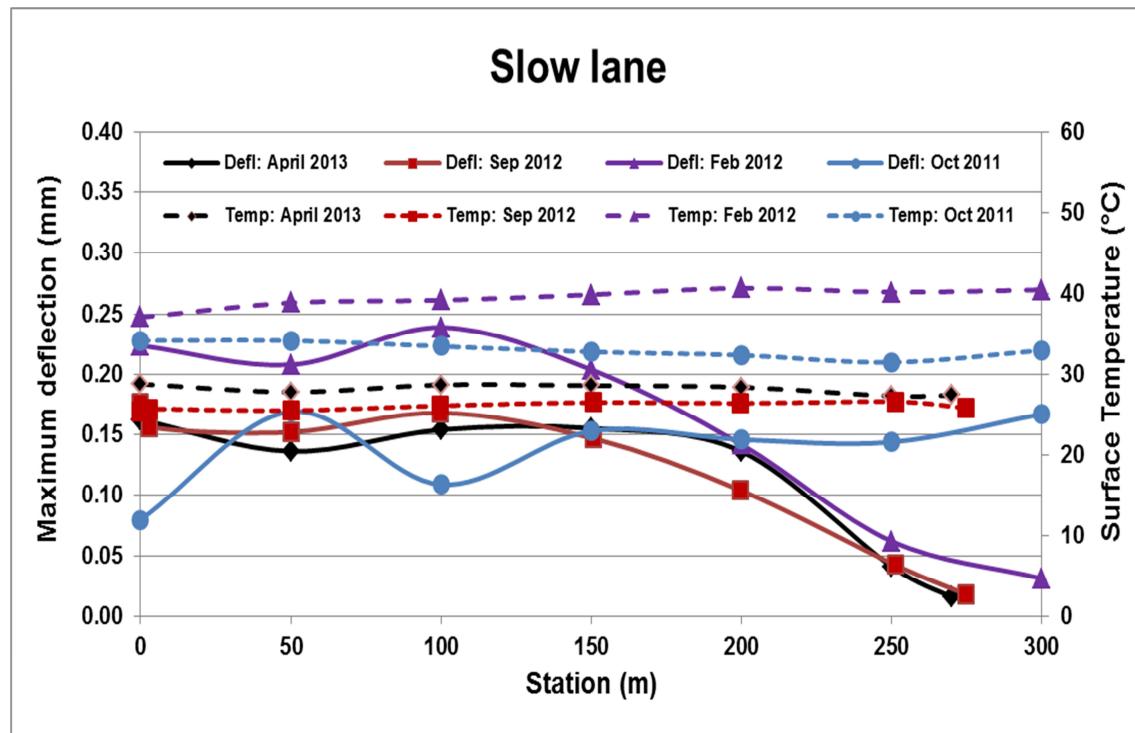
Figure 1: Maximum deflections and surface temperatures for the slow lane (40 kN load)

A third round of Falling Weight Deflectometer (FWD) measurements were performed 20 months after construction by VNA Consulting on the 11th of April 2013. FWD data measured previously (just after construction, 6 months and 12 month after construction) are also included in this report. The raw FWD data are presented in Appendix D. Tables 1 to 4 present the deflection bowl parameters i.e. maximum deflection (Ymax), base layer index (BLI), middle layer index (MLI) and lower layer index (LLI) for FWD measurements performed just after construction, 6,12 and 20 months respectively. Figures 1 and 2 show plots of maximum deflections and surface temperatures for slow and fast lanes respectively. Overall, higher deflections values were measured after 6 months as compared to other inspection measurements (just after construction, 12 and 20 months). It is also observed that higher temperatures were measured during the 6 month inspection. It is difficult to explain the differences in deflections, although temperature could have played a role.

It should be noted that measurements were taken from the lower end of section towards the intersection with Bayhead road but the recorded chainages by VNAC recorded are in the opposite order to the marked ones on site (taking the starting point as 0 as opposed 280).

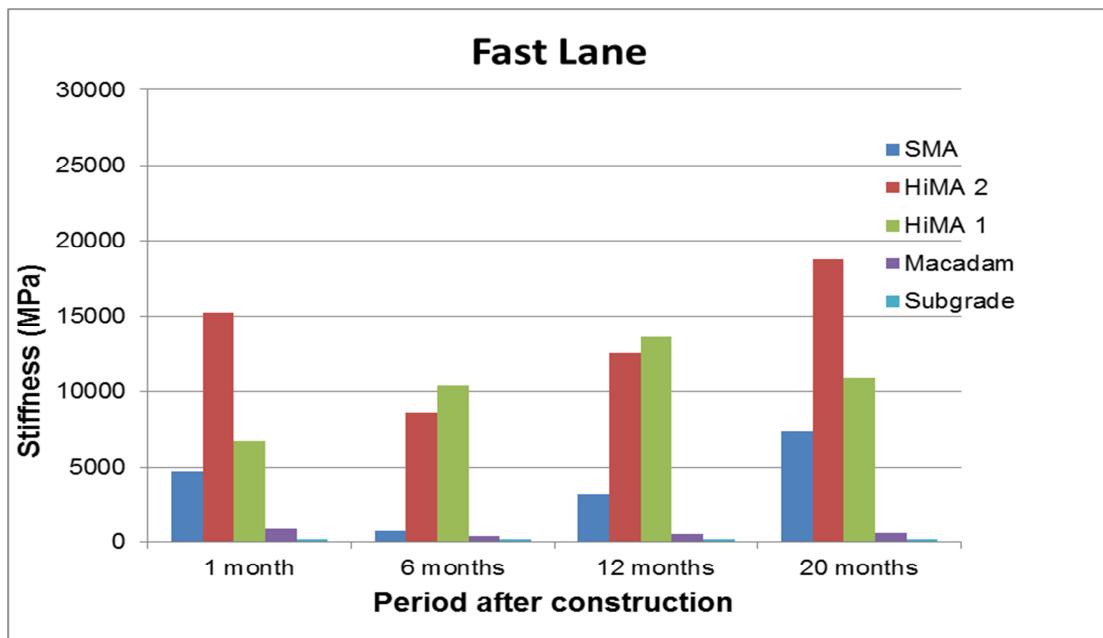
Figure 3: Pavement layer stiffness values for fast lane

The FWD measurements were used to back-calculate the stiffness of the pavement layers using CSIR's latest version of BackGAMES software. Tables 5 to 8 present the average back-calculated stiffness of the pavement layers just after construction, 6, 12 and 20 months after construction respectively. Figures 3 and 4 show plots of the average stiffness values for fast and slow lanes, respectively. The average stiffness values for slow lane appear to be higher than those of the fast lane for both the SMA and the HiMA layers. It is also noted that the stiffness values calculated using 6 months deflection data are generally lower. This could be due to the fact that high deflections values were measured during the 6 months survey.

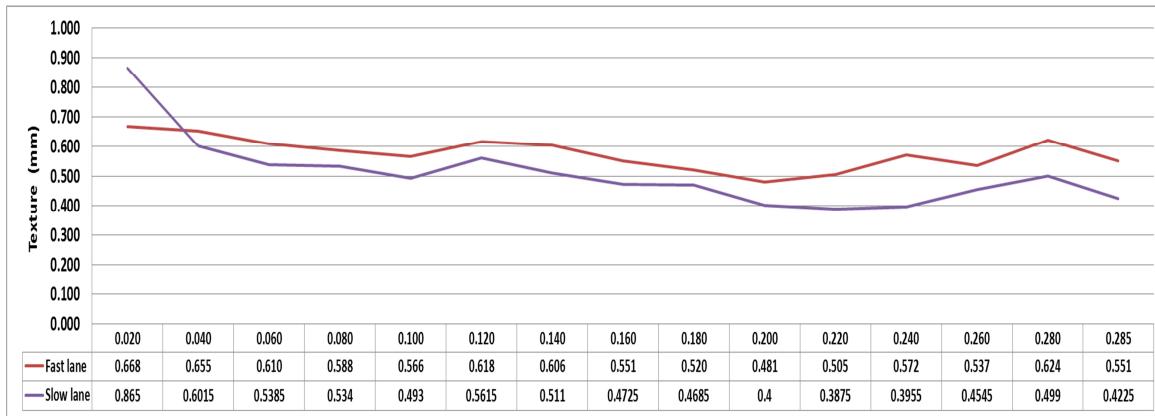
Figure 6: Mean profile depth for slow and fast lanes

A summary of the measured Mean profile depth (MPD) related to the surface texture is contained in Appendix C. Figure 6 shows the average MPD values for the left and right wheel paths along the section for both lanes.

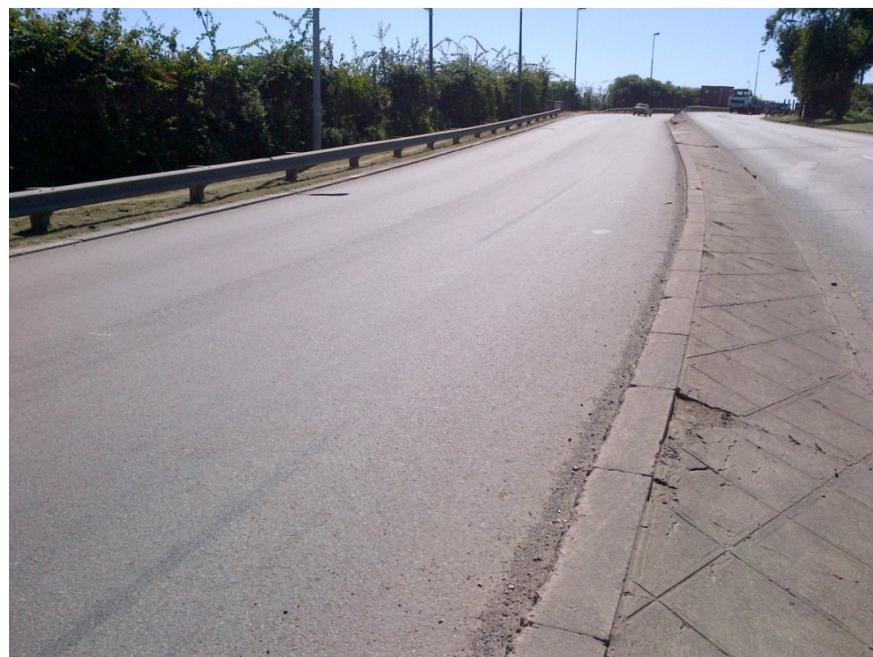
The results of the visual inspection are shown in Appendix A (Tables 7 to 20). Photos taken during the inspection are provided in Appendix B (Figures 8 to 16) to show the condition of the Stone Mastic Asphalt (SMA) surfacing, which is paved on top of the HiMA layers. In general the condition of the trial section has not changed significantly from the previous survey. The overall condition of the pavement is rated as "good" with few defects of degree not more than 3 (condition not yet warning). No critical distresses were apparent during the inspection apart from a few distresses observed on the surfacing discussed below. The section appears to be performing well after 20 months under the heavy traffic situation.

Figure 8: General impression of the trial section

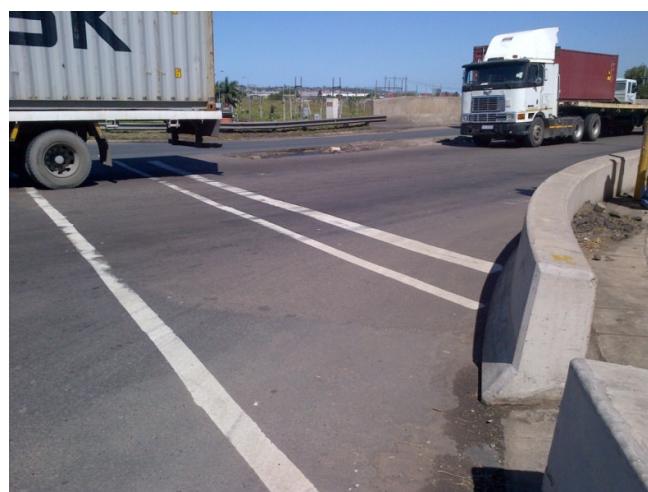
Figure 14: General impression of the section at intersection
